QA-182
Charles Cahall Farm
Church Hill vicinity
Private

INVENTORY FORM FOR STATE HISTORIC SITES SURVEY

Charles Cahall Farm

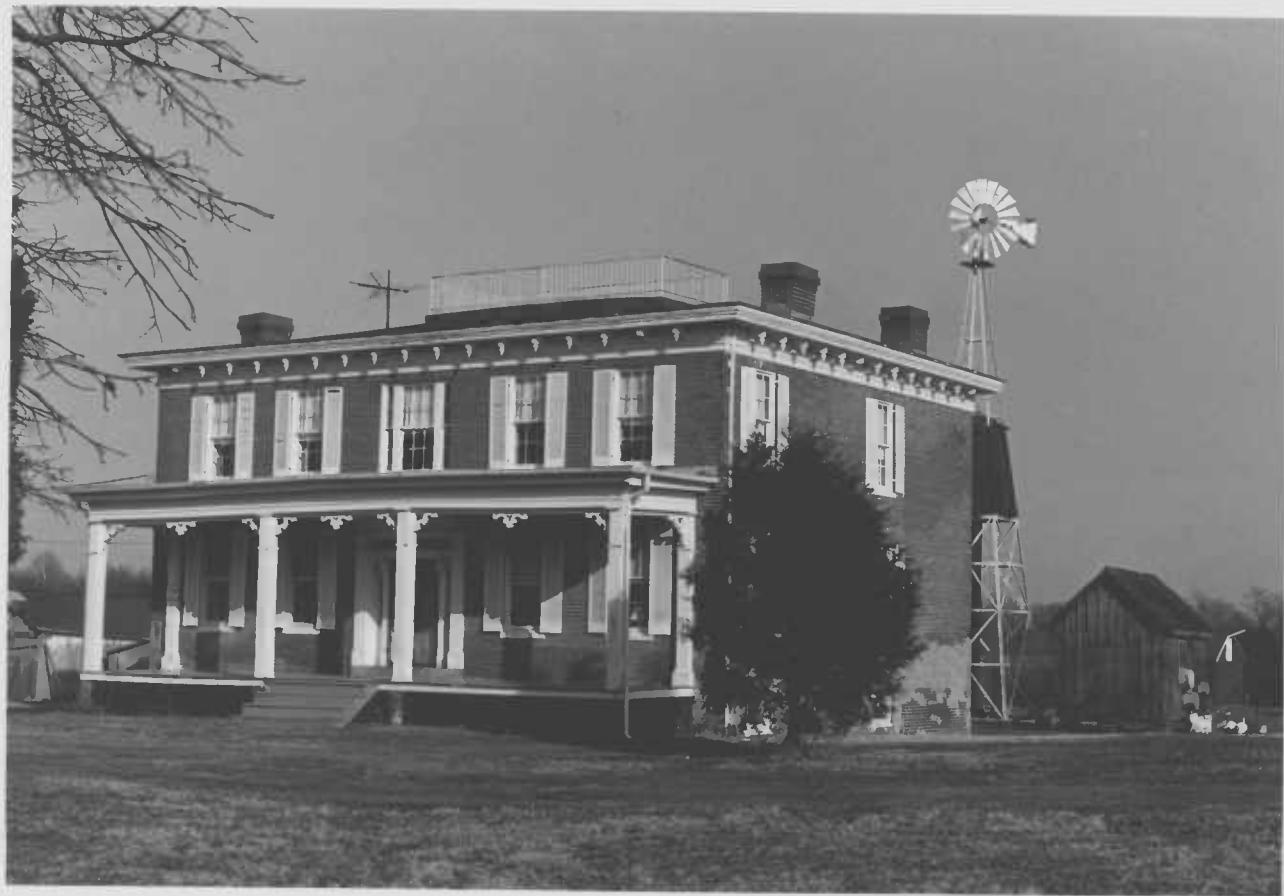
QA-182

Front facade from Southwest

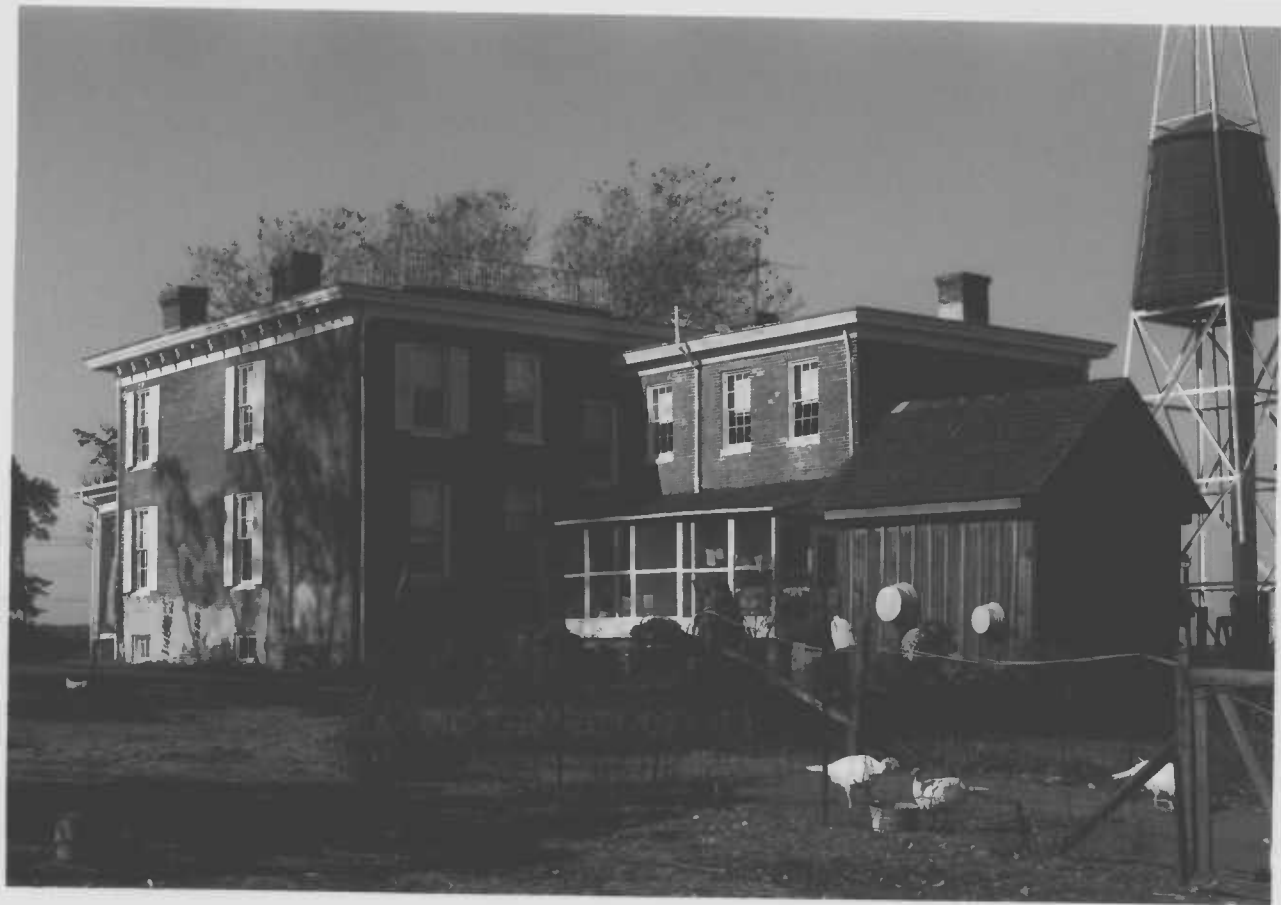
QA-182

Charles Cahall Farm
Church Hill vicinity'
Orlando Ridout V 1980
View from southeast
